COHANSEY RIVER  
CUMBERLAND COUNTY  
NEW JERSEY

# SUNSET LAKE DAM

## NJ 00063

### PHASE 1 INSPECTION REPORT NATIONAL DAM SAFETY PROGRAM

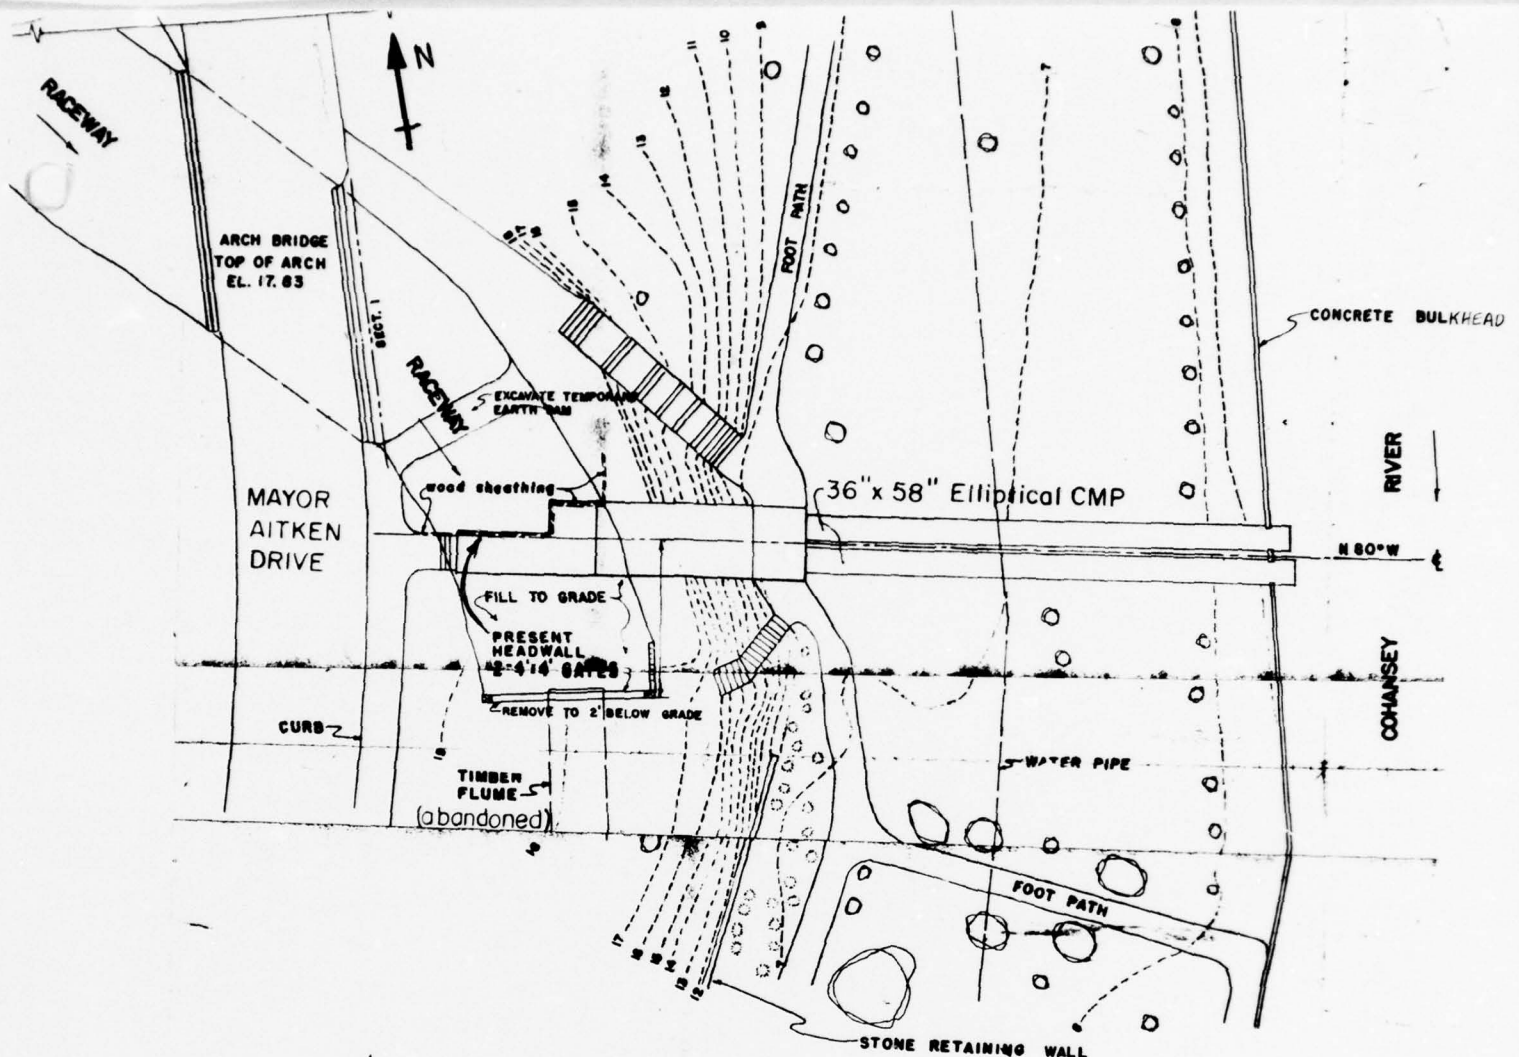
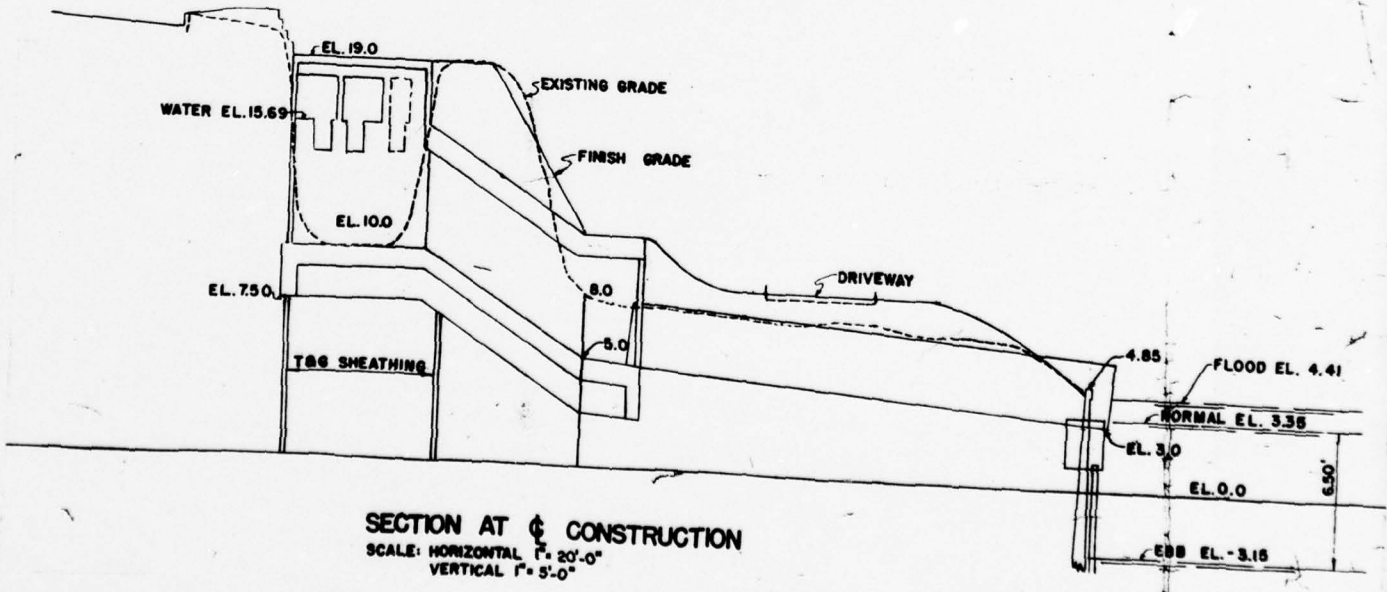
FIGURE 3

The notched-weir drop inlet at the south end of the raceway (see Figure 3) replaced two
